# Easement

Federated Charities FHD-9  
22 South Market Street  
Frederick City, Frederick County, Maryland  
Katherine Grandine, Historian  
R. Christopher Goodwin & Associates, Inc.  
April 2000  
Section 7.1

## ADDENDUM

MHT FHD-9  
Federated Charities  
22 South Market Street  
Frederick, Maryland  
Addendum Section 7.4

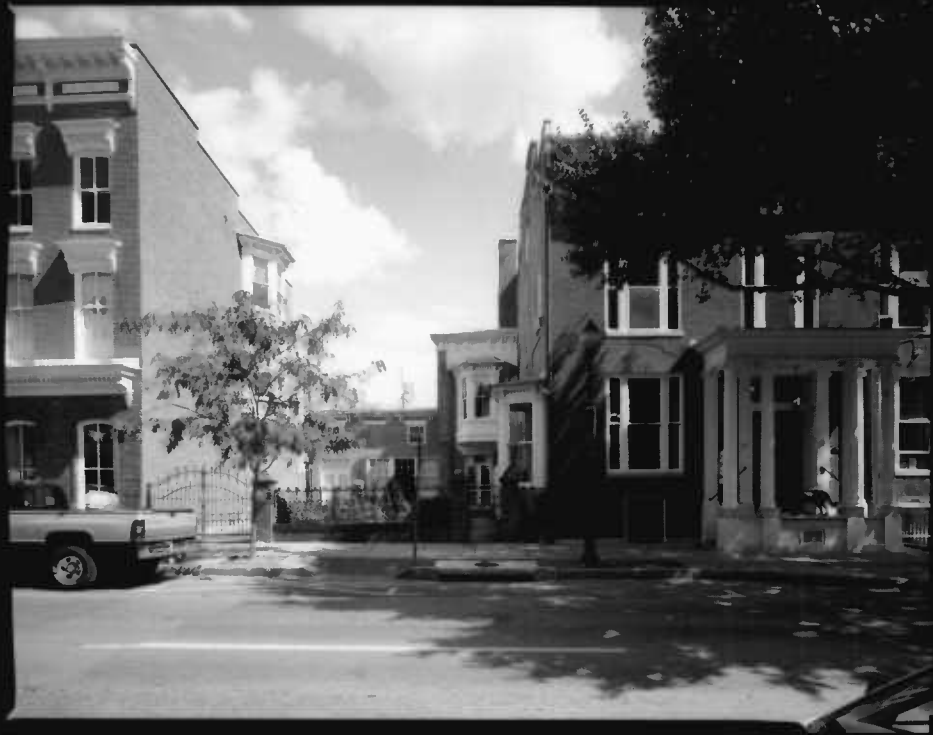
2 of 15

View E of Main House

and stable/carriage house

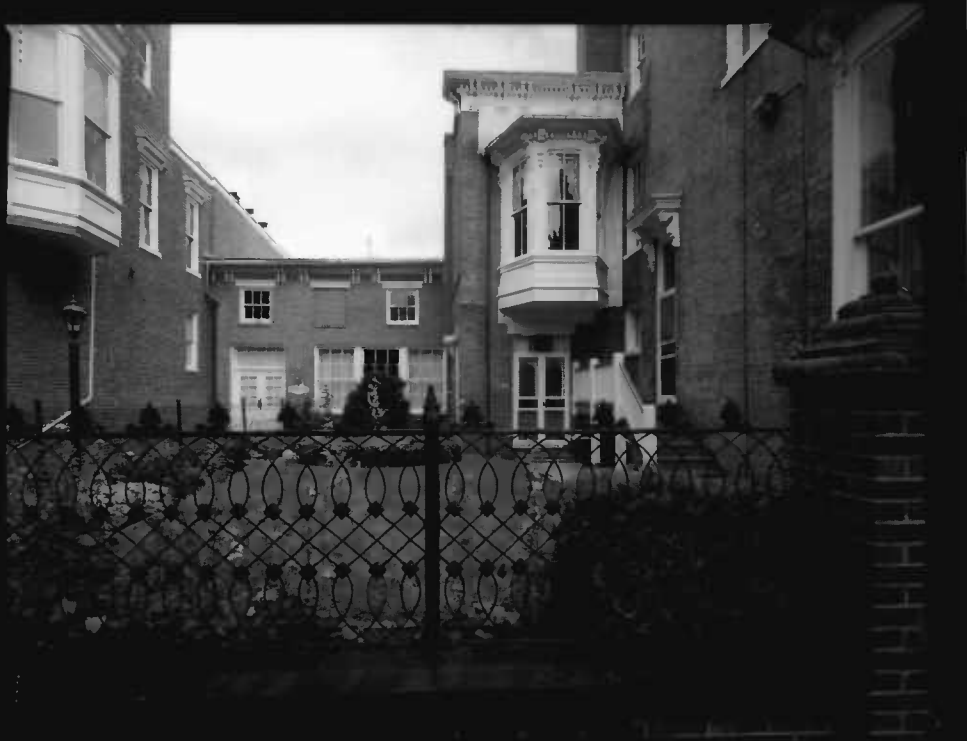
3 of 15

The front (west) elevation is the most ornate portion of the building. It features an elaborate Italianate wood cornice. All window and door openings are the result of renovations undertaken during the 1930s. The main entry contains paired wood-paneled doors, each with six-glass lights, set under a five-light transom. Three six-over-six-light, double-hung sash windows light the first floor. Small three-over-three-light, double-hung sash windows are located in the second floor. Decorative wood lintels are located above the second story windows. The rear (east) elevation contains four six-over-six-light, double-hung sash windows. All windows have brick lug sills.

View E of Stable/carriage house

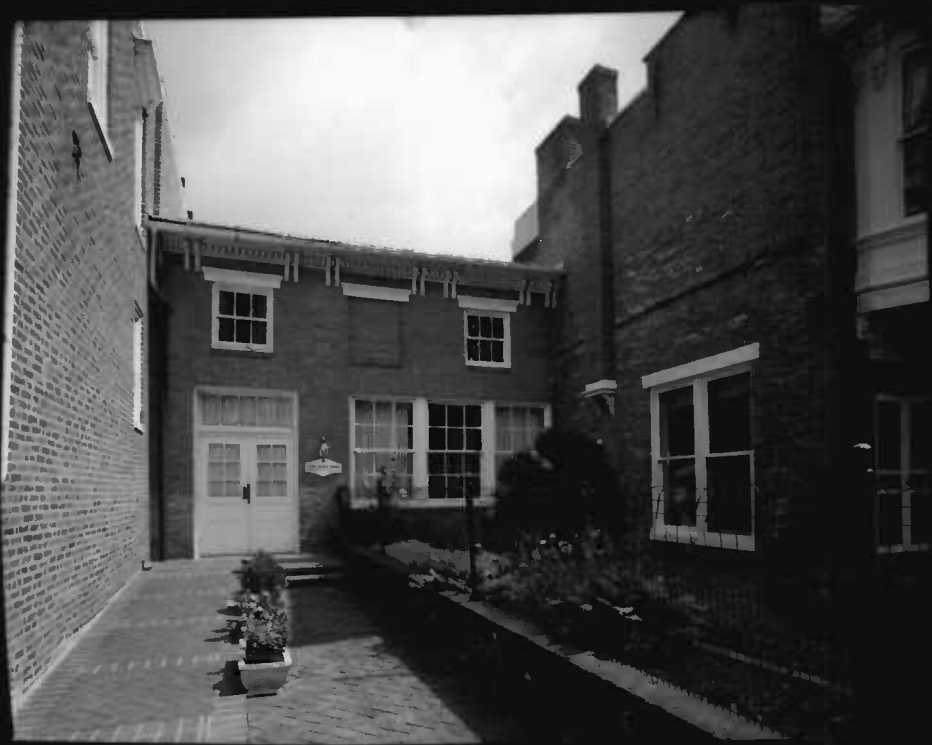
4 of 15

view E of stable/carriage house

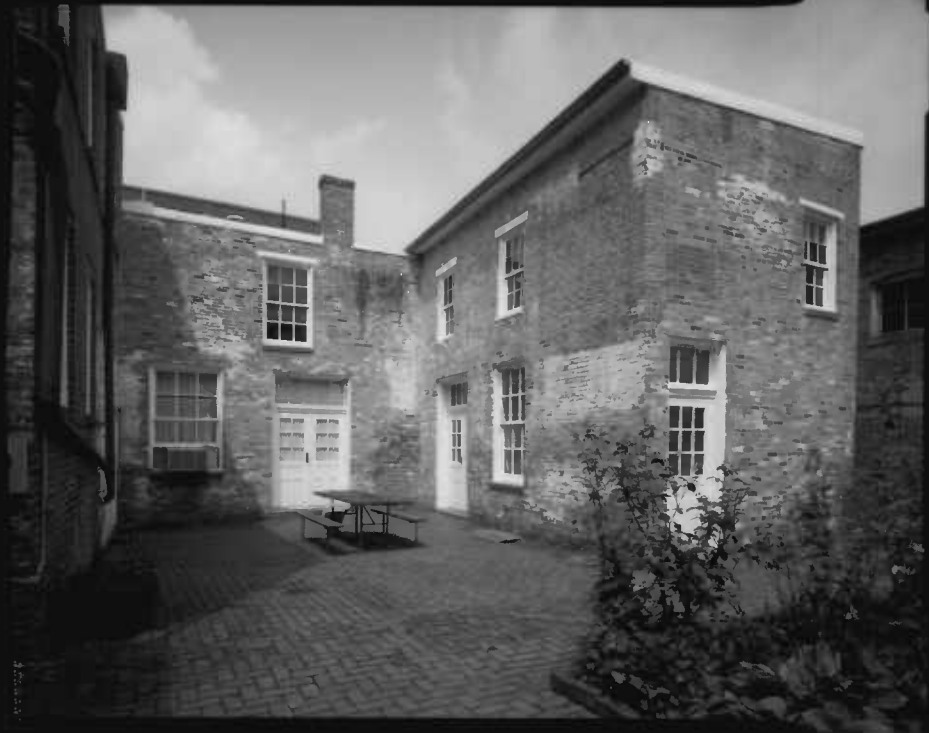
5 of 15

View NE of south elevation

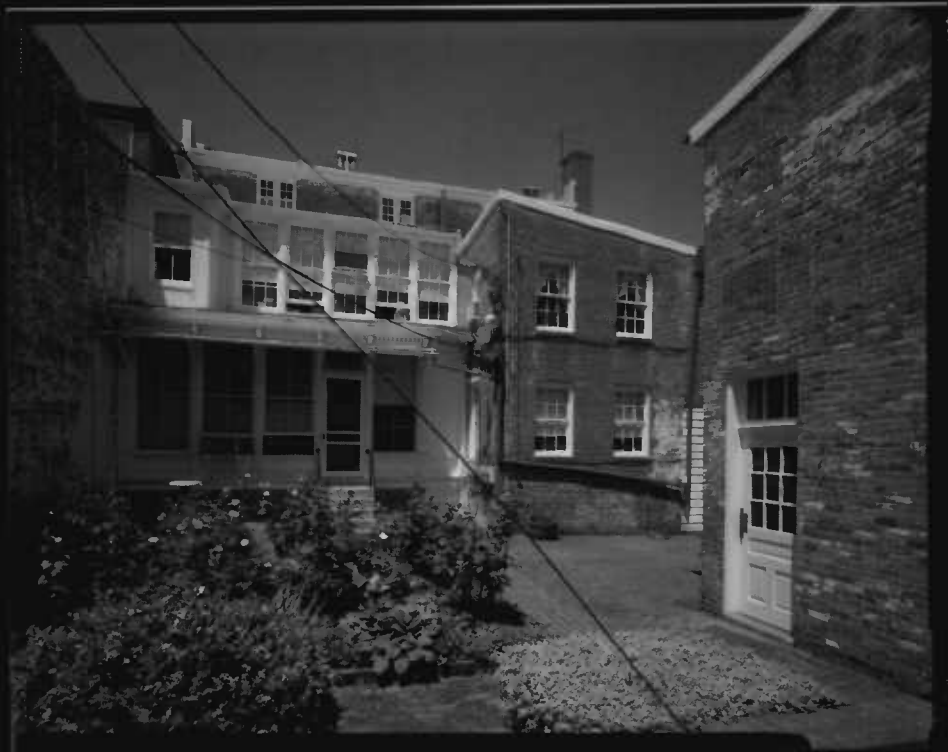
6 of 15

View W of S elevation of Servants gtrs  
and rose garden

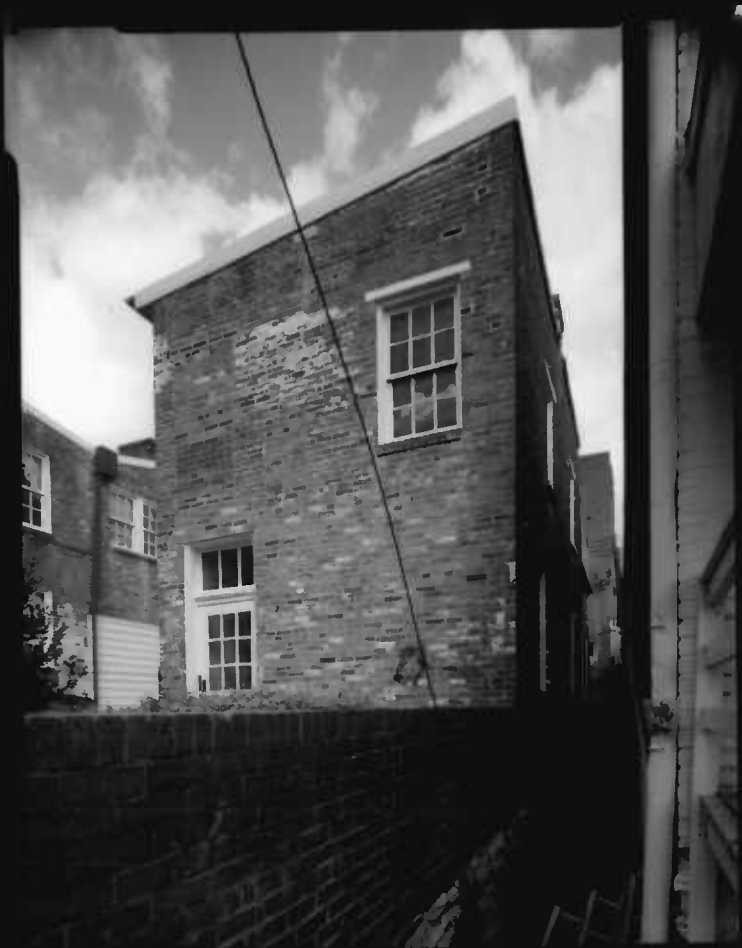
7 of 15

The window and door openings were modified during the 1930s renovations, as evidenced by the prevalence of brick lug sills. The windows on the east, south, and west elevations are six-over-six-light, double-hung sash with wood frames. The door on the south elevation is a wood paneled unit with nine glass lights set under a three-light transom. Paired wood panel doors with six glass lights are located on the west elevation. The opening above the paired doors contains a five-light transom. A large granite slab set in the brick pavement at the base of the west elevation may indicate an original door opening that has been converted into a window.

View N of south and east  
elevations of servants qtrs

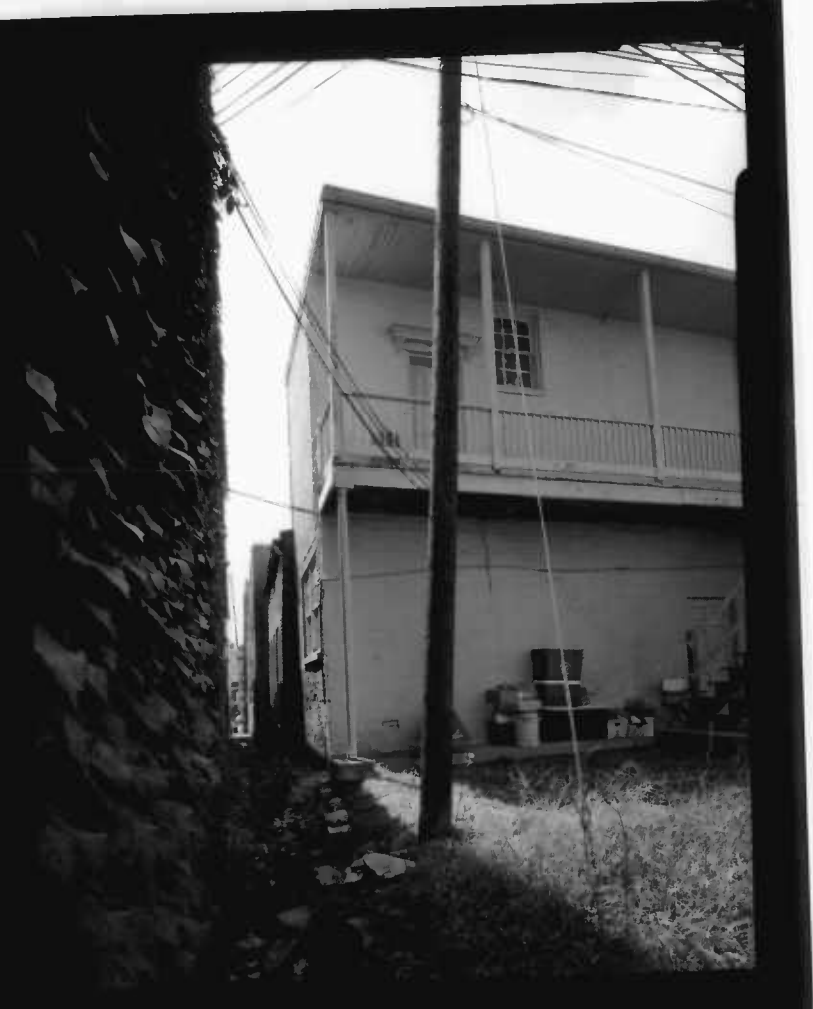
8 of 15

view S of east elevations  
of 16-18 S. Market St  
and stable

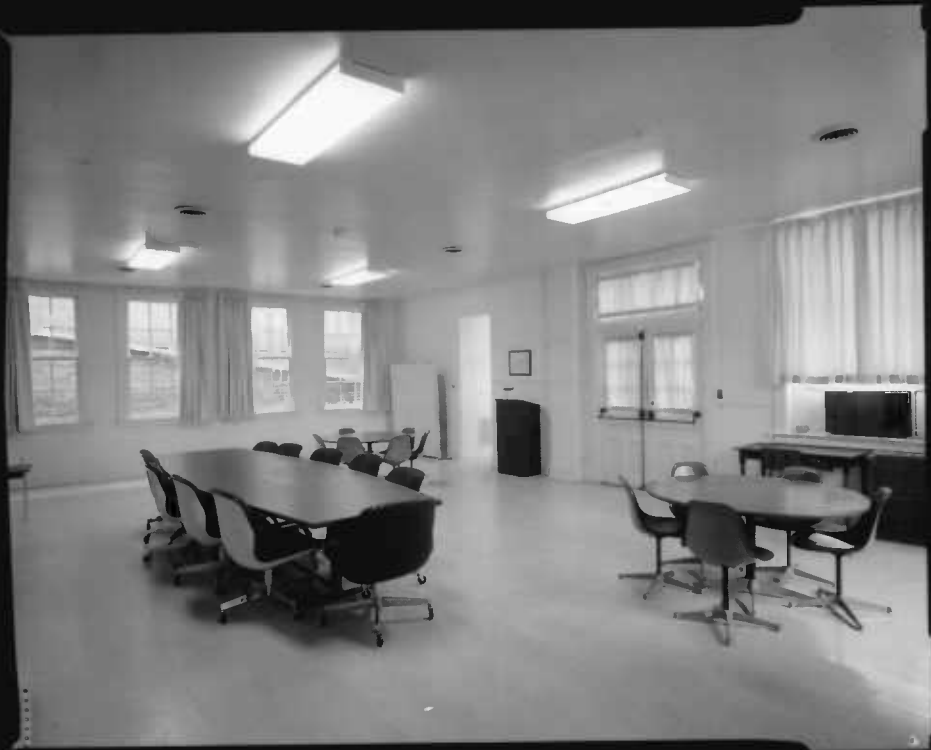
9 of 15

All interior first-floor finishes and fixtures date from renovations undertaken after Federated Charities acquired in the building in 1930. The second story is unfinished. Decorative open brickwork ventilation panels in the shapes of diamonds and crosses are located on the second story of the western section of the north wall. Vertical ventilation slits are located on the second story of the east wall. A wood transom is located on the eastern section of the north wall.

View SE of 1st floor stable/carrage hse

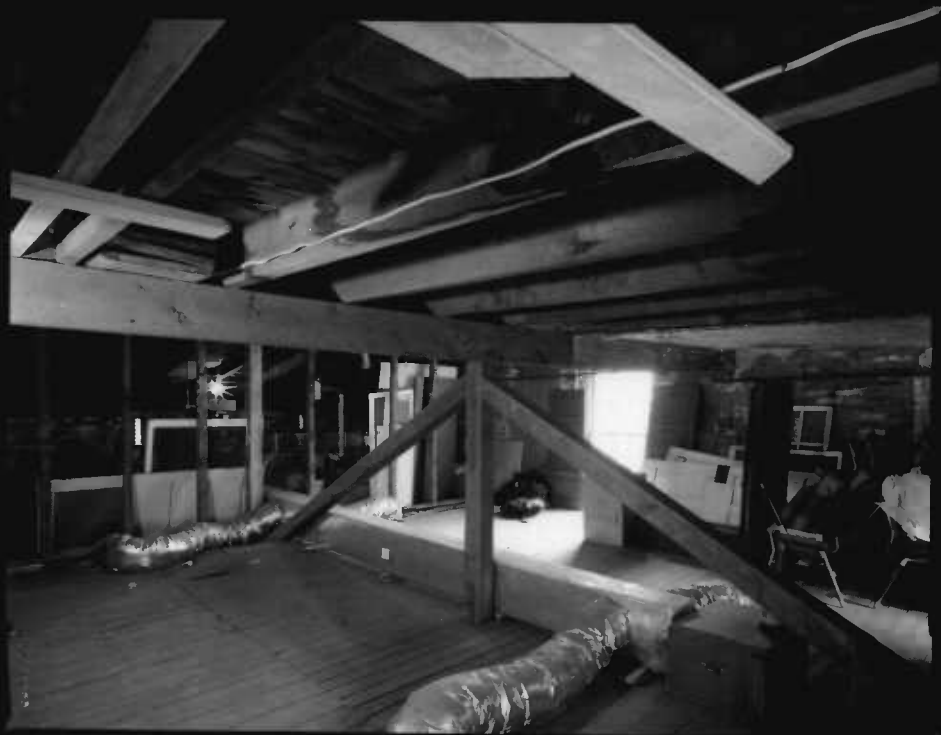
10 of 15

- 8 View S of east elevations of 16-18 South Market Street and stable
- 9 View SE of first floor interior of former stable/carriage house
- 10 View SE of second floor of stable/carriage house showing roof framing and remnants of ceiling plaster along south wall

View SE 2nd floor stable/  
carriage hse.

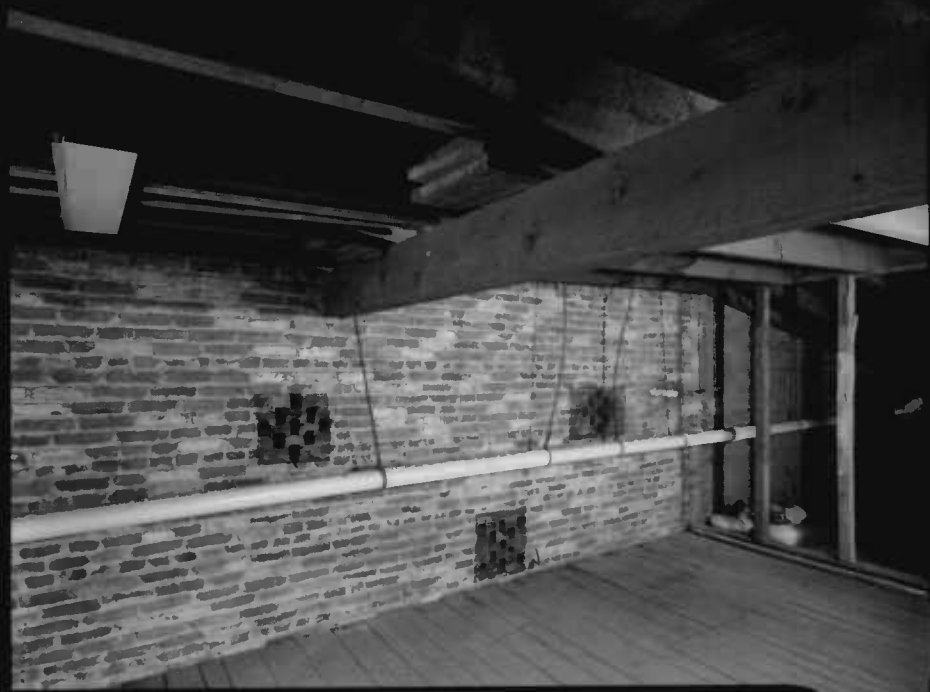
11 of 15

long wood transom on the north wall may have been the original opening to the hayloft, even though the area underneath the transom appears to be infilled with brick similar to the rest of the wall.

- 11 View NE of patterned brick vents in north wall of second story of stable/carriage house
- 12 View SE of brick ventilation slits in east wall of second story of stable/carriage house

View NE of 2nd floor North Wall

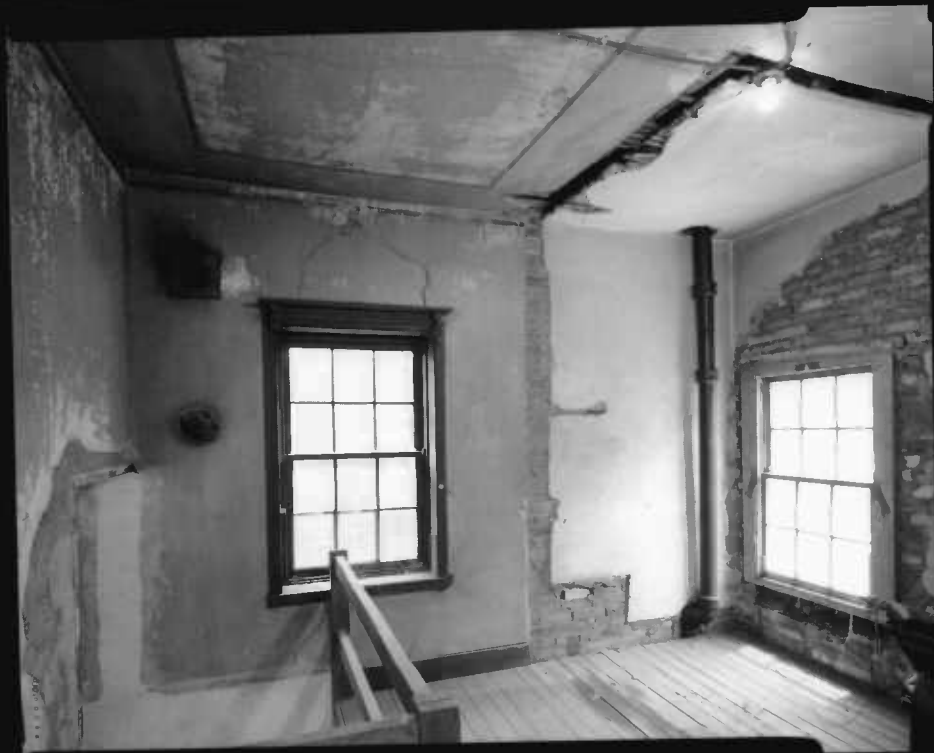
13 of 15

The second floor is divided into two rooms. A notable feature of the second story servants' quarters is the Victorian period wall and ceiling stenciling. These finishes appear to be original and are stylistically consistent with the last quarter of the nineteenth century. This stenciling, along with the wide baseboards and interior window cornices with machine turned finials, are well executed but less ornate than the rich and elaborate finishes found in the main house. The stenciling in the southernmost room is in the shape of an L that indicates that the corner of the room was separated from the stenciled areas by walls. No evidence of a fireplace or chimney was located in this building; however, the remains of stovepipes were noted on the east wall. The stoves were removed when the stairway was installed. During the 1930s, a doorway was punched through the party wall between the second floor servants' quarters and the former stable (Ziek 2000). Infill brick on the second story of the south wall indicates changes in the fenestration and door pattern. A small infilled window is located midway between the first and second floors of the south elevation.

View E of east and south walls, 2nd floor  
servants qtrs

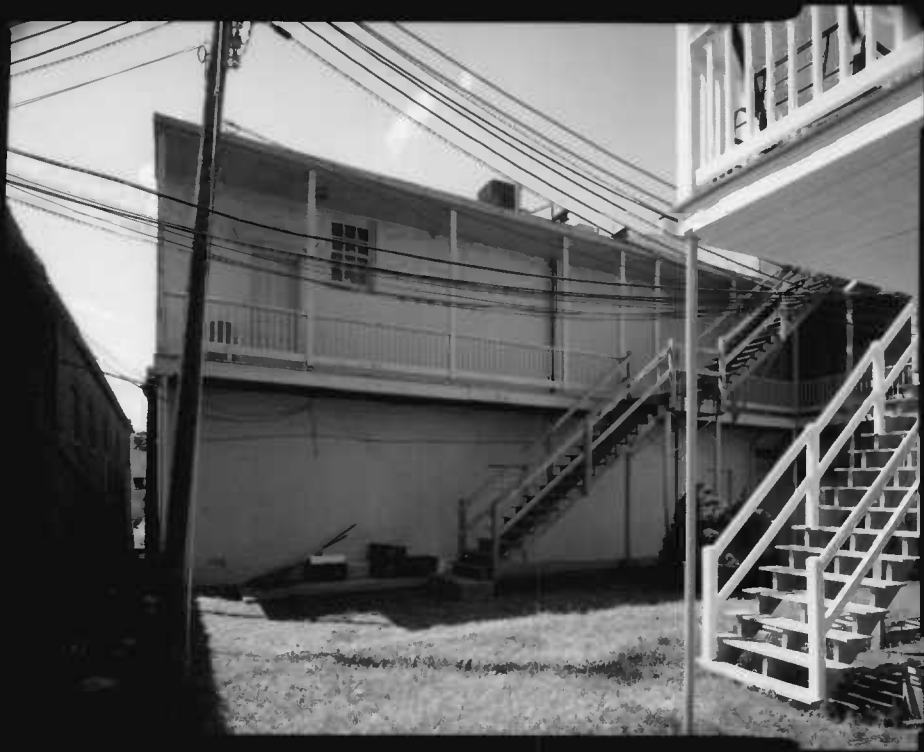
FHD-8  
Federated charities, 16-18s. Market St.  
Frederick MD

- 15 View SW of back building at 16-18 South Market Street (FHD-8)
